Thermal Analysis of an Installation Fault Concerning a Ripple Control Transformer

By V. Chatziathanasiou, G. T. Andreou, D. P. Labridis

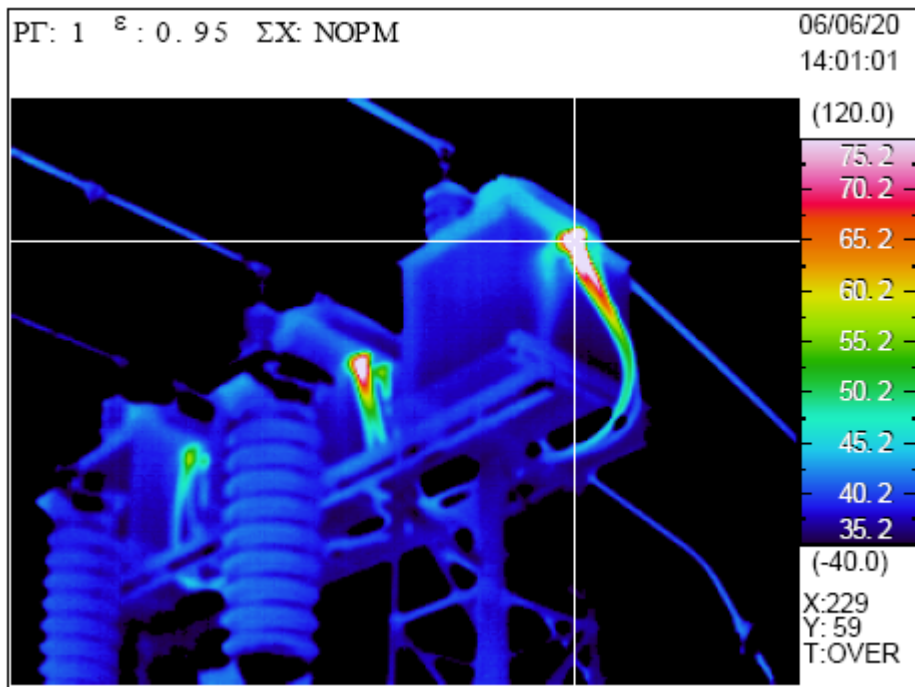
Recently a problem occurred in one of the transformers, when its feeding cable blew. The cable was replaced with a new one, which again blew after some time. The cable was replaced again, and thermal imaging was used to monitor its function. The thermal imaging results are shown in Fig. 1

As shown in the figure, the malfunctioning feeding cable exhibited at its junction with the transformer a temperature of about 120°C, whereas the respective temperature of the rest of the installation was less than 50°C, as would normally be expected. Further analysis of the incident indicated that the junction between the feeding cable and the transformer was made for aluminium cables, whereas the feeding cable itself was made of copper. Evidently the aluminium junction could not handle the temperature of the copper cable, the result being its overheating and the destruction of the cable.

Fig. 1. Thermal image of the malfunctioning feeding cable
