# The analysis of mural painting „The Crucifixion” in St. John the Baptist and St. John the Evangelist basilica in Toruń.

Jarosław Rogóż\*, Adam Cupa\*, Bogusław Więcek\*\*

The analysis of mural painting was executed on commission of the District Conservation Office in October 2007. The analysis aimed for establishing the state of preservation of the artefact and it comprised: localisation of structural anomalies of the painting (delaminating plasters and lime-wash layers), identification of the materials used and revealing the composition of the painting covered with lime-wash. The non-destructive analyses were made with the use of different bands of electromagnetic radiation. The UV reflectography was employed, UV-fluorescence, VIS, coloured infra-red, near infra-red and thermographic analysis. The non-destructive methods were complemented with micro-chemical analyses and instrumental analyses: gas-chromatography GC, X-ray fluorescence XRF and infrared spectroscopy FTIR.

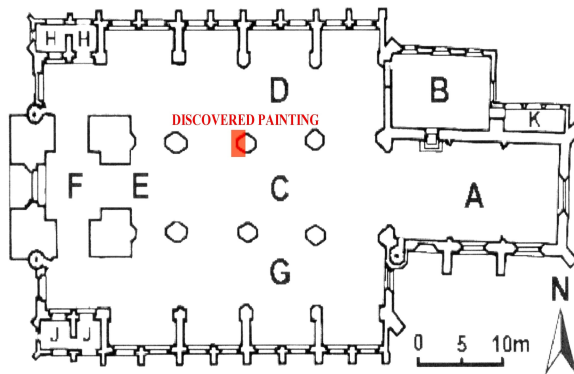
Fig. 1. Location of the mural in the church-plot.  
A - Chancel, B - Vestry, C - Nave, D - North aisle,  
G - South aisle, J - South porch, H - North porch.

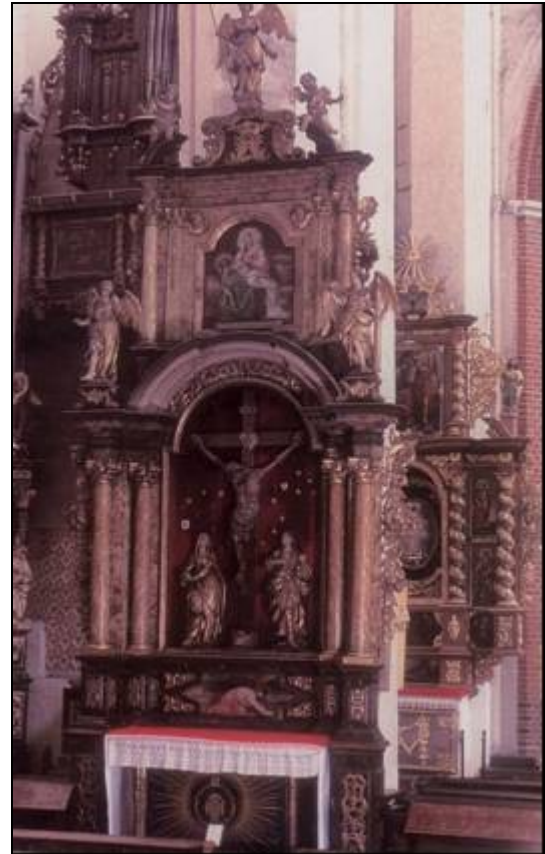
Mural painting, being the subject of our analysis is located on the second pier, separating the north aisle from the nave. First traces indicating the presence of polychrome have been discovered in July 2007, when the side altar of the Holy Cross (dated 1739) was dismantled, due to the planned transfer to conservation atelier for further treatment.

Fig.2. Side altar of the Holly Cross, 1739 with a painting "Deposition" 1640, behind which the analysed mural painting was discovered.

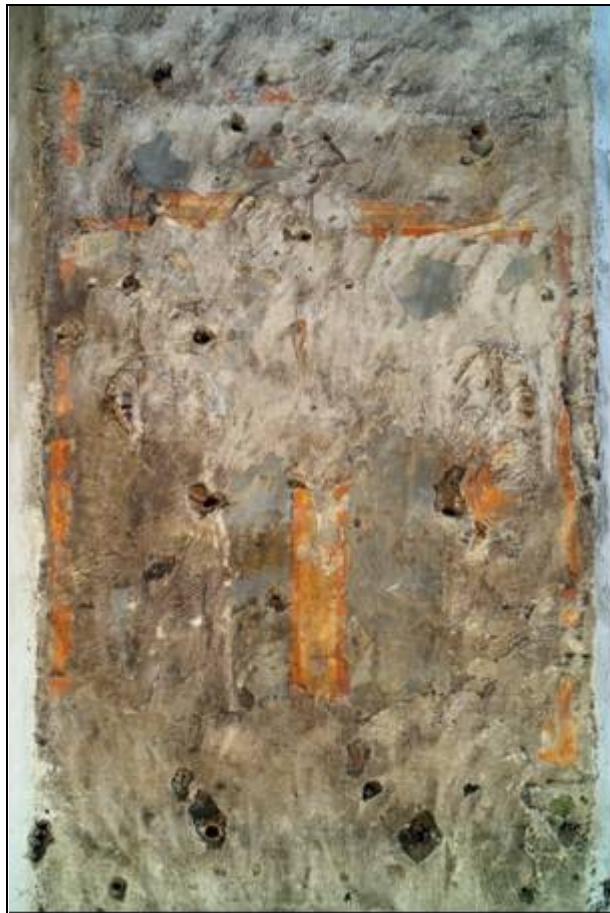
Fig.3. Fragments of composition visible in lacunae of lime-wash covering the painting. Image in visible light, scattered.

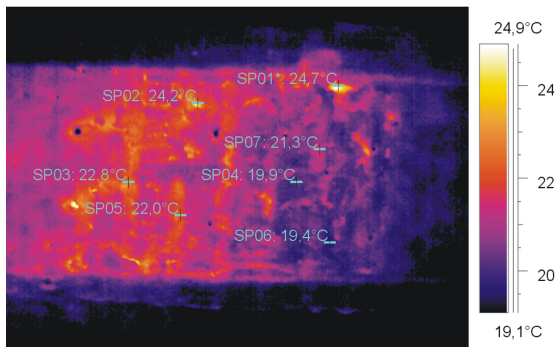
The most complete information on the condition of painting has been obtained by thermographic analysis conducted with the use of both active and passive techniques. They allowed to reveal the areas of thermal anomalies caused by local delamination of plaster and lime-wash layers to various extent (Fig.4.). The area, in which the plaster is considerably well bound with lime-wash was identified. The analysis of thermographs allowed also for revealing the brick-bond of the support (Fig.5).

Fig.4. Thermograph of the polychrome

The measurement was taken during heating the surface of the wall with halogen lamps. The temperature range of the taken measurement amounted (24.9 – 19.1 °C) and the range of radiation wavelength 7.5 - 14 $\mu$ . The measurement parameters: the artefact emission factor 0.80; air temperature 15 °C, Rh in vicinity 50% ; distance 3m; transmission 1.00. The highest temperatures (24.7 and 24.2 °C) mark the areas of strong delamination of lime-wash. Medium temperatures (22.8, 22.0 and 21.3°C), have been recorded in areas of blisters within the plaster structure. The highest temperatures correspond with stronger delamination. The lowest temperatures , between 19.9 and 19.4 °C indicate the areas, where the plaster is considerably well bound with lime-wash.

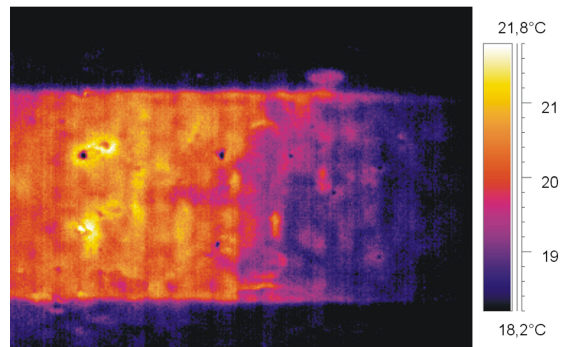
Fig.4. Thermograph of the polychrome

The measurement taken during cooling of the wall. The temperature range of the taken measurement amounted (21.8 – 18.2 °C) and the range of radiation wavelength 7.5 - 14 $\mu$ . The measurement parameters: the artefact emission factor 0.80; air temperature 15 °C, Rh in vicinity 50%; distance 3m; transmission 1.00.

The recorder thermograph revealed the bond of the brick support, the regularity of which has been disturbed by some (more separated) blisters within the plaster.

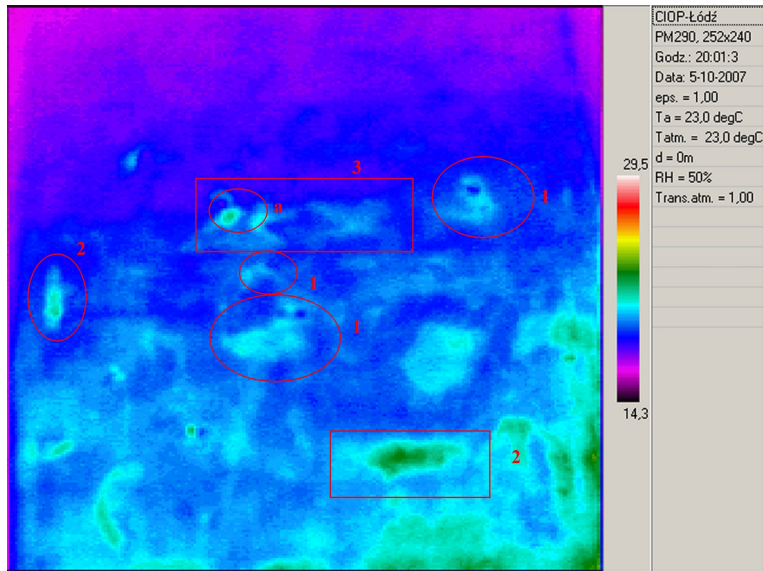
The analyses with dynamic thermography (the method of heat-wave with the Fourier analysis of the images) allowed to locate the areas of a composite system of delaminations, in which the delaminating lime-wash covers the blistered plaster. This technique allowed also to reveal the places in which only the delaminating lime-wash appeared. The analysis revealed both the blisters in plaster in the areas of exposed paint layer and in the areas of plaster covered with well-adhering lime-wash.

Fig. 6. Thermograph of the upper part of the painting.  
 The analyses allowed to locate the areas – appearing on various depth – where double delamination occurred: the blister of lime-wash on the blister in plaster (1). The areas of delaminating lime-wash were identified (2) and the delamination of plaster and lime-wash layers (a) surrounding the injury (3).

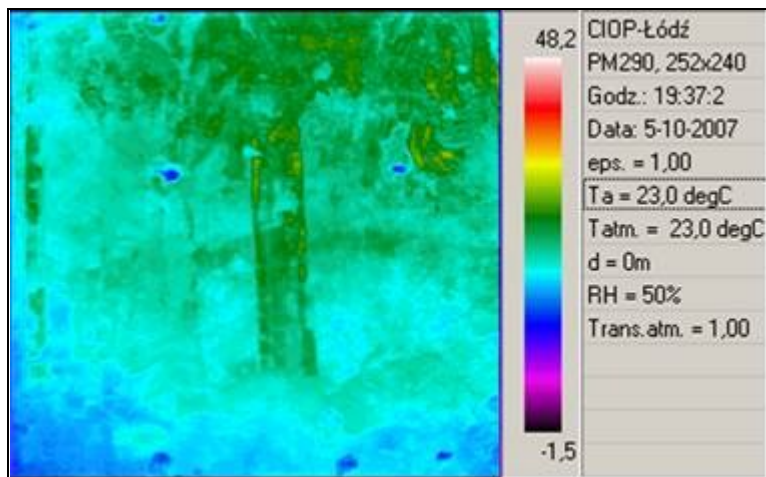
The quality of thermal image, allowing for visualisation of underlying paint layer is highly influenced by numerous anomalies appearing in the structure of polychrome. Those are: blisters within the plaster (of diverse extent of delamination); the so called systems of double (superimposing) delamination of plaster and lime-wash; blisters in lime-wash and areas of separation and crumbling of lime-wash. Additional disturbances are introduced by the exposed parts of polychrome, injuries in areas of halos and local differences in the thickness of lime-wash. Those factors deform the image of revealed composition.

Fig.7. Thermograph of the lower part of analysed painting.

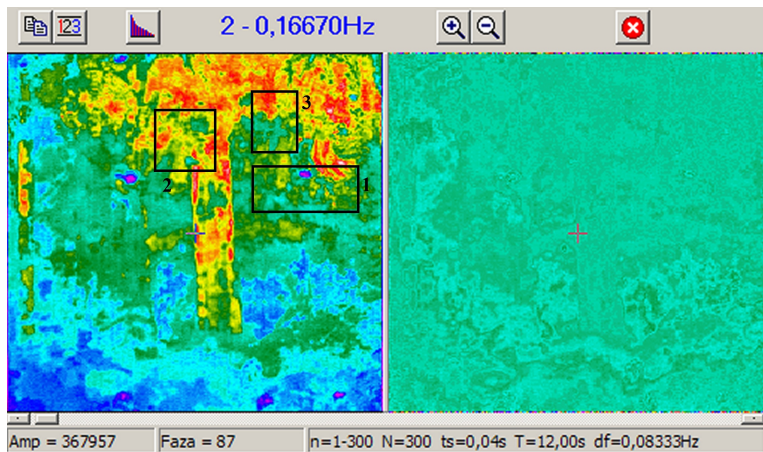
Fig. 8. The transformed thermographic signal - Fast Fourier Transformation. The distribution of amplitude on the right (amplitudogram) and the phase-shifting on the left (phase plot). In result of this analysis one receives the information on differentiation of the inner structure of painting. Using this technique the range of large delamination of plaster in the area of exposed blue paint layer (1) was revealed. Also the wide-spread blisters in plaster in the left part of the painting (2) were identified as well as blisters in the area between the cross and the figure in the right side of composition (3).

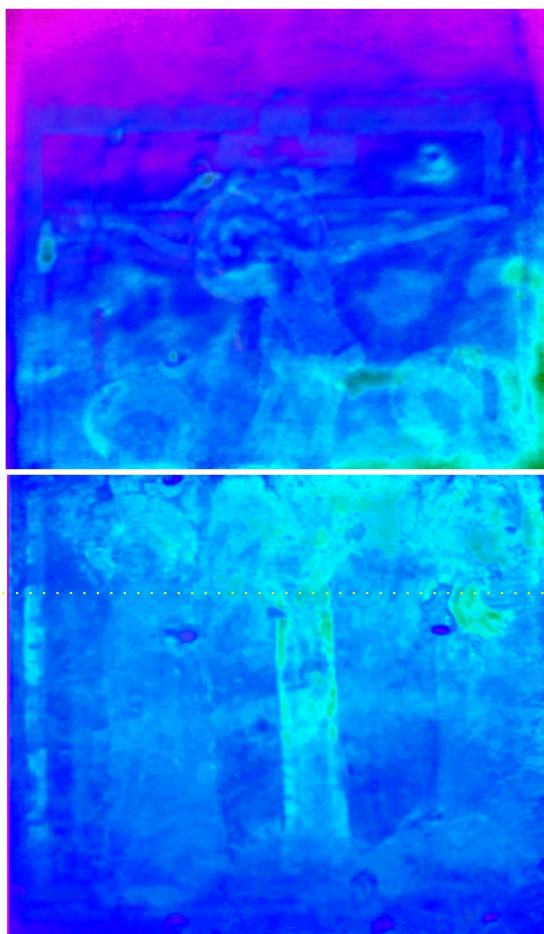
Good results in revealing the outlines of composition have been obtained thanks to developing the suitable research methodology. The analysed images were recorded with the use of synchronic thermography (*lock-in*). Out of the particular sequences (300, 1000) 80 contrast images (single frames) were selected. The characteristics of obtained images have been processed to normalise the colours using the Paint Shop Pro 7 software. Then using the Combine Z5 software the obtained bitmaps of the artefact have been combined in various sequences (for instance 45 – 50 frames) into a final image. Basing on the conducted analyses the outlines of composition were revealed. (Fig. 9, 10).

Fig.9. Thermograph partly revealing the outlines of the upper part of composition.

The quality of thermal image, allowing for visualisation of underlying paint layer is highly influenced by numerous anomalies appearing in the structure of polychrome. Those are: (1) blisters within the plaster (of diverse extent of delamination); (2) the so called systems of double (superimposing) delamination of plaster and lime-wash; (3) blisters in lime-wash and areas of separation and crumbling of lime-wash. Additional disturbances are introduced by the exposed parts of polychrome, injuries in areas of halos and local differences in the thickness of lime-wash.

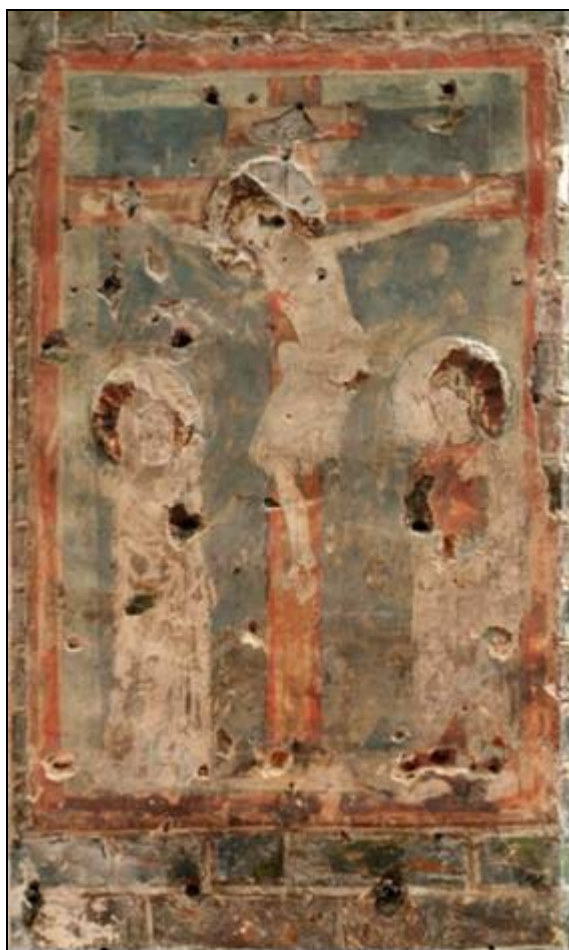
Fig.10. Photograph of the mural painting in St. John the Baptist and St. John the Evangelist basilica in Toruń, taken after the conservators have removed the lime-wash layer. Condition in November 2007.

The achieved results allowed to reveal the outlines of composition prior to removing the lime-wash layers concealing the painting.

Reconstructed composition of the painting, being the outcome of executed thermographic analyses using the method of heat-wave combined with Fourier image analysis and the rightly developed algorithm for computer image processing in considerable extent corresponds with the above presented (Fig. 10) original painted composition, exposed by the conservators.
